PULLING THE PLUG ON INEFFICIENCY

Ron de Rijk, Curtiss-Wright EST Group, USA, presents a safe repair solution for critical-use heat exchangers.

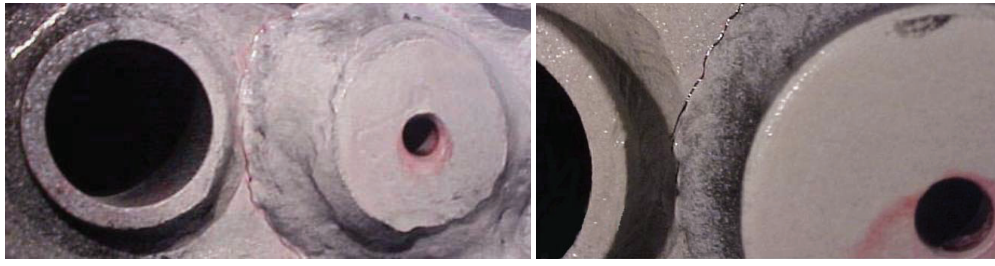
Figure 3. Circumferential cracks after the units have gone back into service and were exposed to extreme temperature cycles.

Previously, the producer had only used the time-consuming repair process of installing tube plugs with a thread. These plugs were welded into the tubes with pre and post-heat treatment. Not only did this process add days to a repair job, it also greatly increased the likelihood of circumferential cracks in the vicinity of the repair after the exchanger was brought back online and exposed to the extreme temperature cycles of the waste heat boiler.

The plugs were matched to the metallurgy of the tubes and installed using a controlled force, which protected the tube sheet ligaments and adjacent tube sheet joints from damage. Each plug was installed in just minutes, and successfully maintained a leak-tight seal under extreme thermal and pressure cycling. This solution ultimately extended the operating life of this critical use heat exchanger, while reducing operating costs at the same time.
