MAINTENANCE PROCEDURES FOR GRIPTIGHT®, GRIPTIGHTMAX®, AND GRIPTIGHT ELBOW HIGH PRESSURE TEST PLUGS

WARNING! FOR PROPER OPERATION, GRIPTIGHT (GT), GRIPTIGHTMAX (GTMAX), AND GRIPTIGHT ELBOW (GTLBO) PLUGS MUST BE ASSEMBLED AS SHOWN.

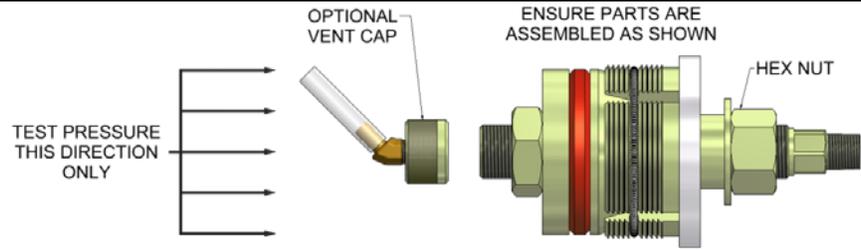
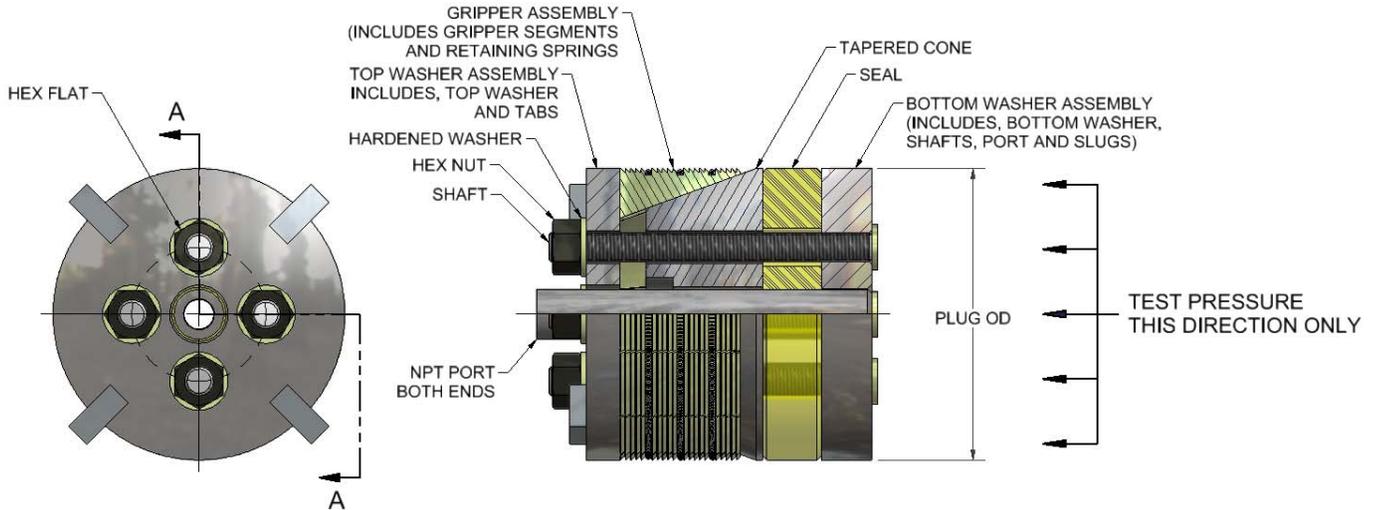
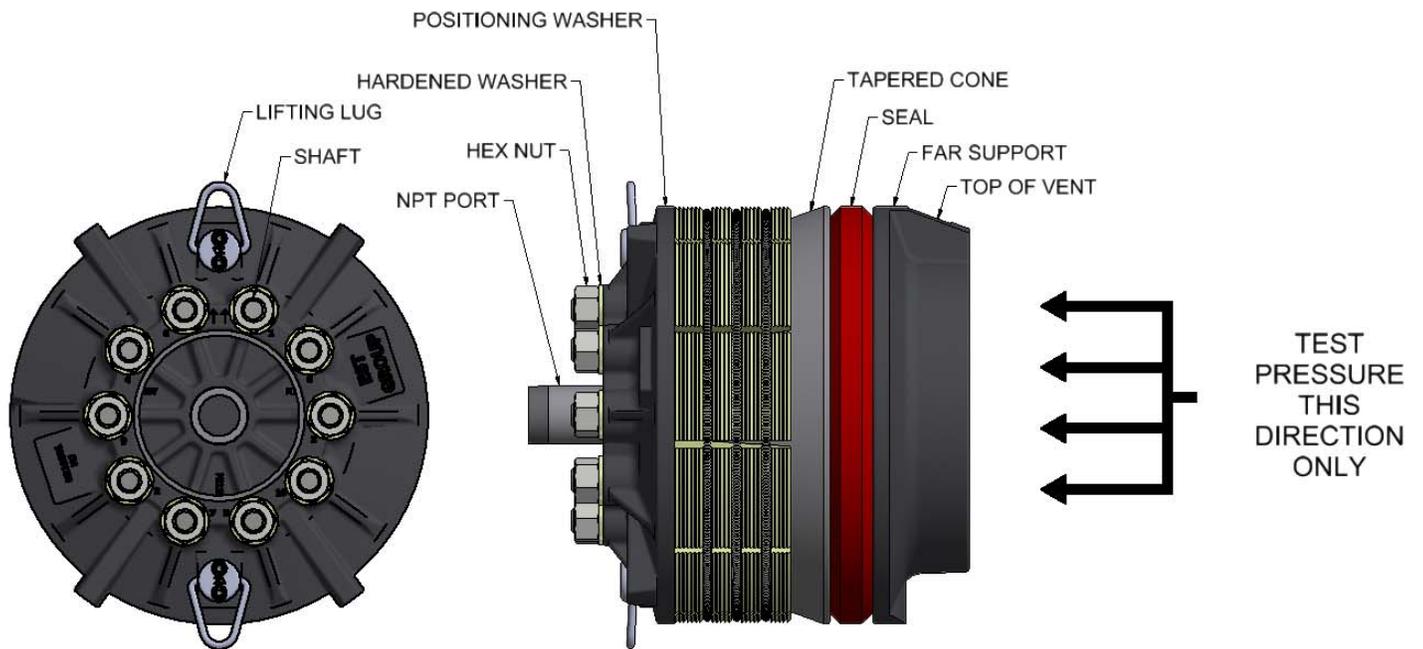
GRIPTIGHT TEST PLUGS

- ◆ **GT, GTMAX, AND GTLBO TEST PLUGS ARE DESIGNED TO WITHSTAND PRESSURE IN THE DIRECTION SHOWN IN THE ABOVE DRAWINGS. DO NOT USE THESE PLUGS FOR REVERSE PRESSURE APPLICATIONS. FOR REVERSE PRESSURE APPLICATIONS, GTRP TEST PLUGS ARE TO BE USED.**

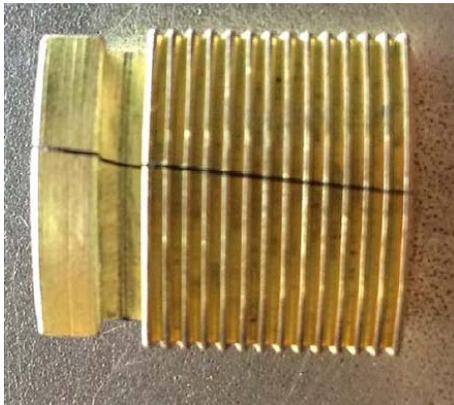
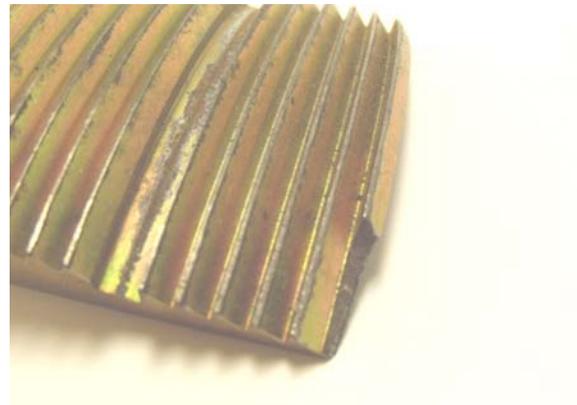
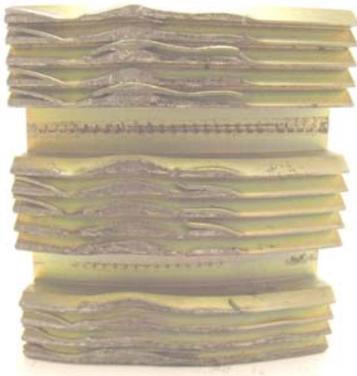
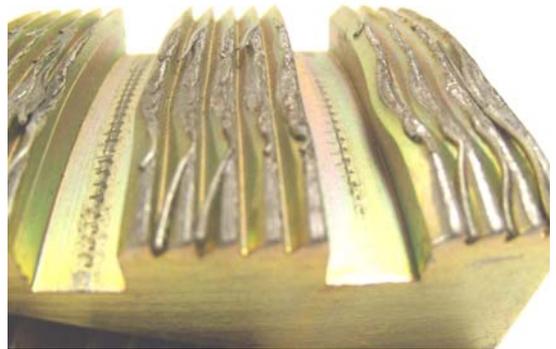
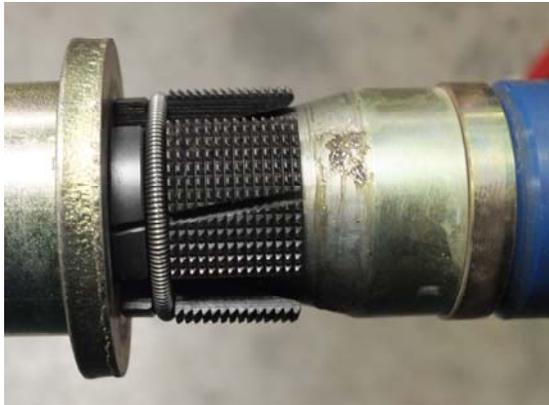
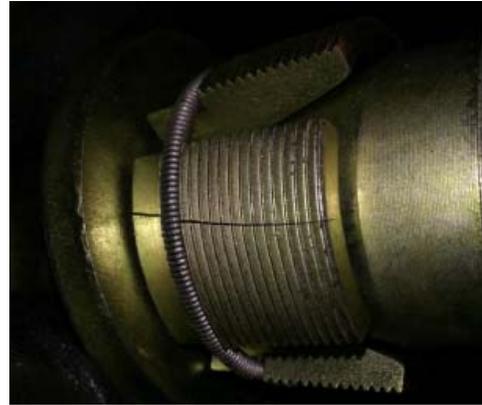
SEE PICTURES BELOW OF GRIPPER DAMAGE

1. Prior to ANY pressure testing, each GT, GTMAX, GTLBO Test Plug **MUST** be inspected for proper operation.
2. When inspecting grippers, carefully examine each segment, as well as, the individual serrations located on the outside of each segment.
3. The following, although not limited to, are examples of gripper segments that need to be taken out of service and replaced:
 - 3.1. Worn or flattened serrations
 - 3.2. Chipped serrations
 - 3.3. Sheared off or missing serrations
 - 3.4. Deformed or cracked segments or segments

4. If there is any doubt in the integrity of any gripper segment, remove it from service and replace. Contact EST Group Customer Service for assistance in replacement or evaluation.

1. If there is any damage to the grippers, they may not effectively grip or “bite” into the pipe/vessel wall. The gripper serrations see, in some cases, a tremendous amount of force while under rated pressure. If there is material missing or deformed, the load may be distributed unevenly and could result in improper operation, failure or ejection.

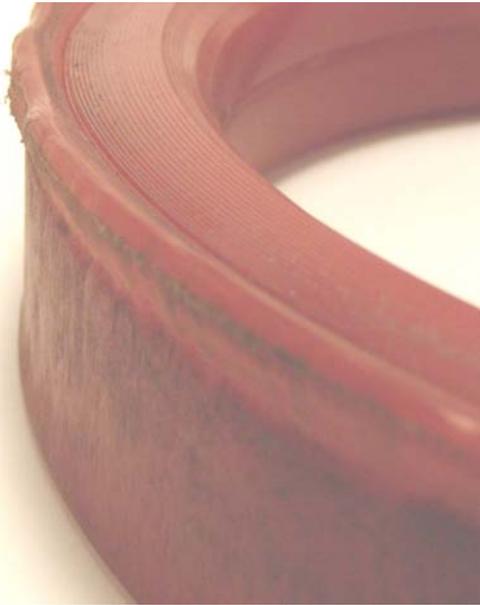
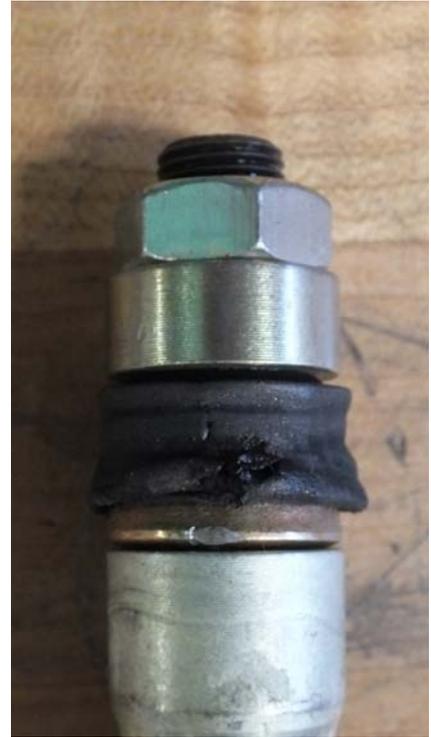
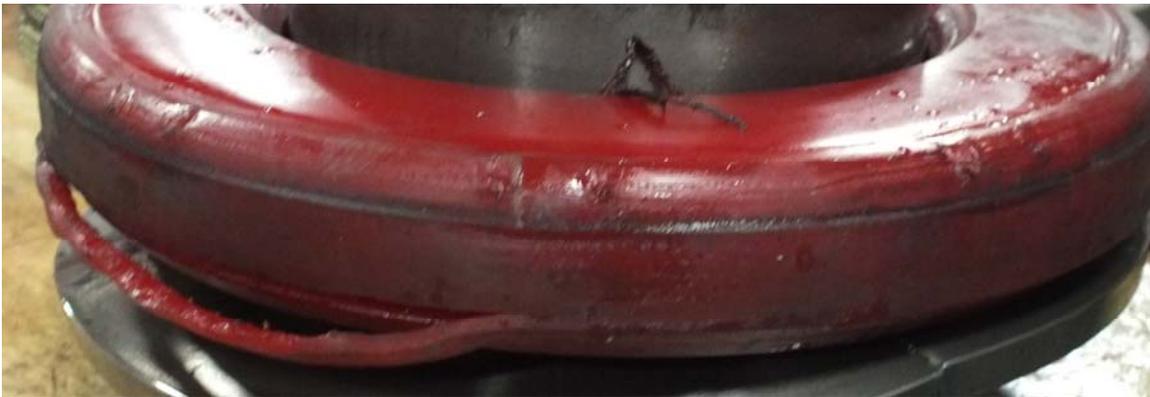
SEE PICTURE BELOW OF SEAL DAMAGE

11. The following, although not limited to, are examples of seal deformation that may create a leak-path or a situation that may result in difficulty removing the Test Plug after pressure testing:

- 11.1. Large rips or tears of the seal
 - 11.2. Large pieces missing from the outside diameter of the seal
 - 11.3. Significant cuts of the outside diameter of the seal

12. If any of these conditions are present, the seal needs to be removed from service and replaced. Contact EST Customer Service for assistance in replacement or evaluation.
