Case Study: Condenser Plug Change-Out Application

EST Group Removes 1100 Rubber & Tapered Fiber Plugs and Damaged Sleeves from Condenser Water Boxes for Fossil Fuel Power Customer

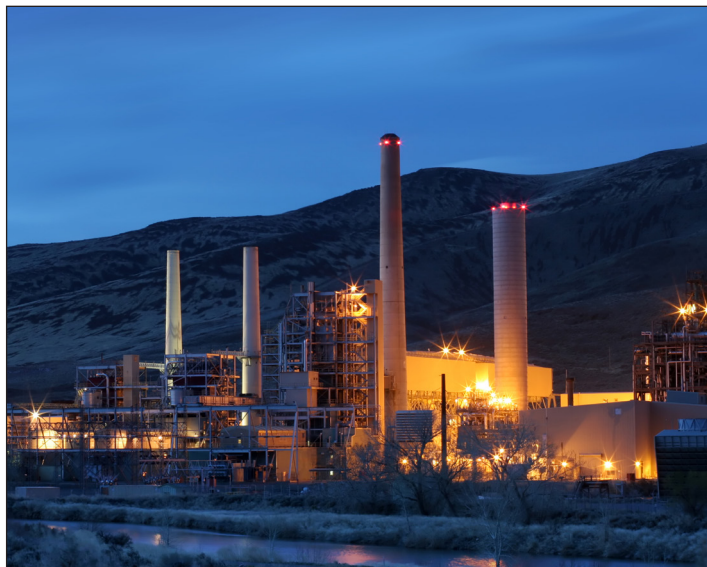
EST Group was contacted by a leader in the Power-Fossil Fuel (Oil) industry, whose plant suffered plug failure (rubber and tapered fiber) in their condenser during winter when water in the tubes froze, causing plugs to eject. Subsequently, leaking tubes took on seawater (salt water), causing damage to other components downstream in the system. The leaking condenser tubes caused problems that could have been avoided.

EST Group Field Services team removed approximately 1100 existing rubber & tapered fiber plugs and tube sleeves from their condenser water boxes and replaced them with Pop-A-Plug® CPI/Perma Tube Plugs (V899H and V919H 70/30 CuNi). Additionally, the Field Services team also verified and corrected tubesheet maps for the customer.

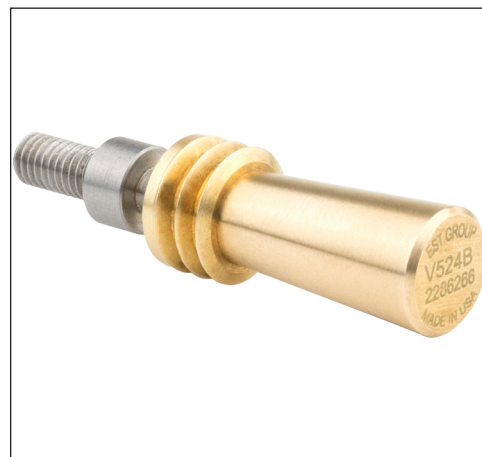
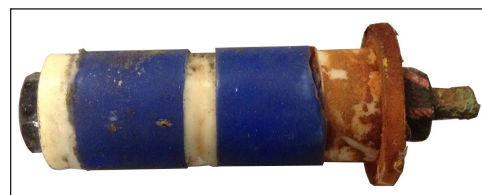
The customer realized the temporary rubber and tapered fiber plugs they were using were costing them more money, and doing more harm than good. When tapered/hammered-in pins fail, they can turn into lethal projectiles that can pose a real safety hazard for workers, and in this case also caused additional damage to the customer's equipment. This issue was eliminated by installing Pop-A-Plug® CPI/Perma Plugs. Pop-A-Plug® Tube Plugs are able to provide a safe, permanent and reliable solution that is quick and easy to install. In fact, the installation went so smoothly, the team of five, who were onsite for eight days, were able to complete work one day ahead of schedule, saving the customer additional money.
