Effective HX Tube Plugging for Ammonia & Urea Services

Safe Solution for Fertilizer Production

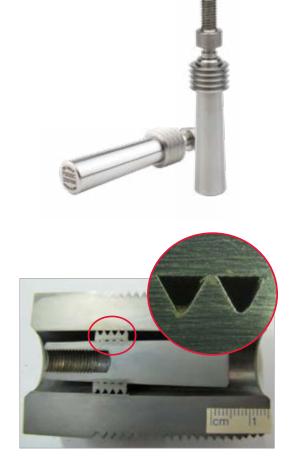
Pop-A-Plug Sectioned Serration Detail

EST Group engineers and manufactures Pop-A-Plug[®] Heat Exchanger Tube Plugs to serve as the safe and reliable tube plugging solution for these critical processes. It provides a safe, controlled, and repeatable method for sealing heat exchanger tubes with installed stability better than a welded plug. The installation method only takes minutes and protects against damage to tube sheet ligaments and the adjacent tube sheet joints. Plug material is always matched to the host tube to prevent any undesirable galvanic interaction and maintain a leak-tight seal under extreme thermal and pressure cycling.

- Pressure Ratings up to 7000 PsiG (483 BarG)
- No welding required
- Reduce downtime from days to hours
- Controlled and repeatable installation
- Unique breakaway prevents damage to tube and tube joint
- Offers the lowest life cycle cost when compared to alternative tube plugging methods
- Helium leak tight seal to 1 x 10⁻¹⁰ cc/sec
- Meets ASME PCC-2 (Article 312) requirements
- Suitability and type tested by TUV
